Penetrations in Fire Rated Walls and other construction elements

What is the hazard?

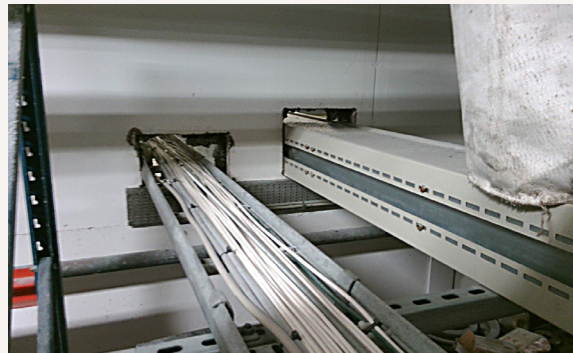
Picture shows an example of unsealed penetrations through a fire rated wall.

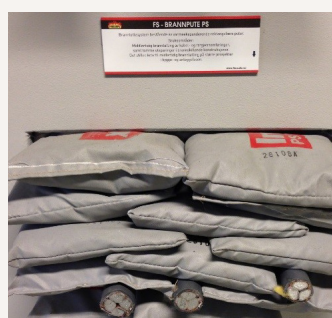
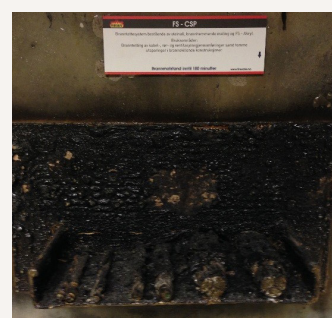
This Hazard Info Sheet is and is intended to be a presentation of the subject matter addressed. Although the authors have undertaken all measures to ensure the correctness of the material, it does not purport to list all risks or to indicate that other risks do not exist. If P&C Insurance does not give any guarantee thereof and no liability is assumed by reason of this Hazard Info Sheet as it is only advisory in nature and the final decisions must be made by the stakeholder. It shall not be applied to any specific circumstance, nor is it intended to be relied on as providing professional advice to any specific issue or situation.
